**Potable Water Pipe Condition Assessment For a High Rise  
Condominium in The Pacific Northwest**

December 3, 2012

Performed by: David M. Coles, PE, President, Coles Consultants and  
Daniel R. Robles, PE, MBA Community Engineering Services, PLLC

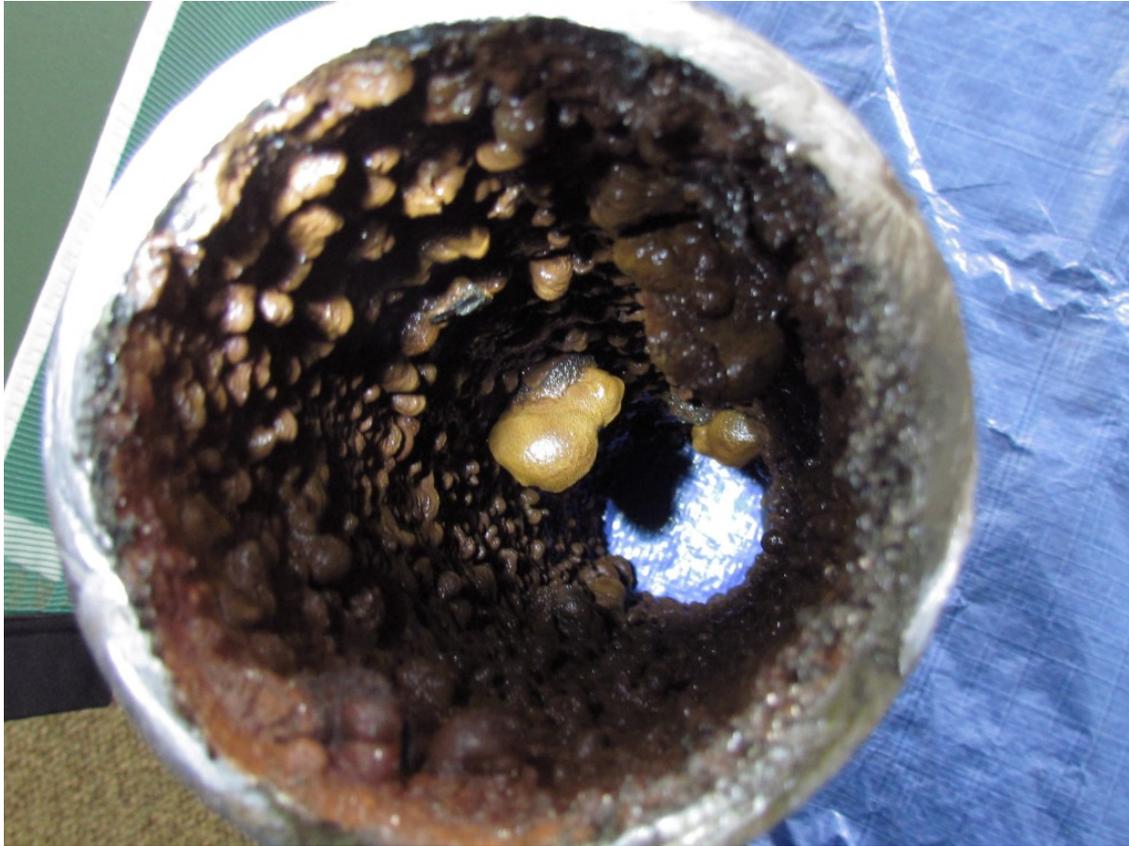
**Figure 1a:** All 3-inch pipe showed similar nodulation and pitting. However, schedule 40 wall thickness leaves substantial material remaining. The large surface area and widespread rusting would likely be a source of metallic contaminants. Large nodules break off easily and could restrict flow in elbows, valves and settle in low spots.

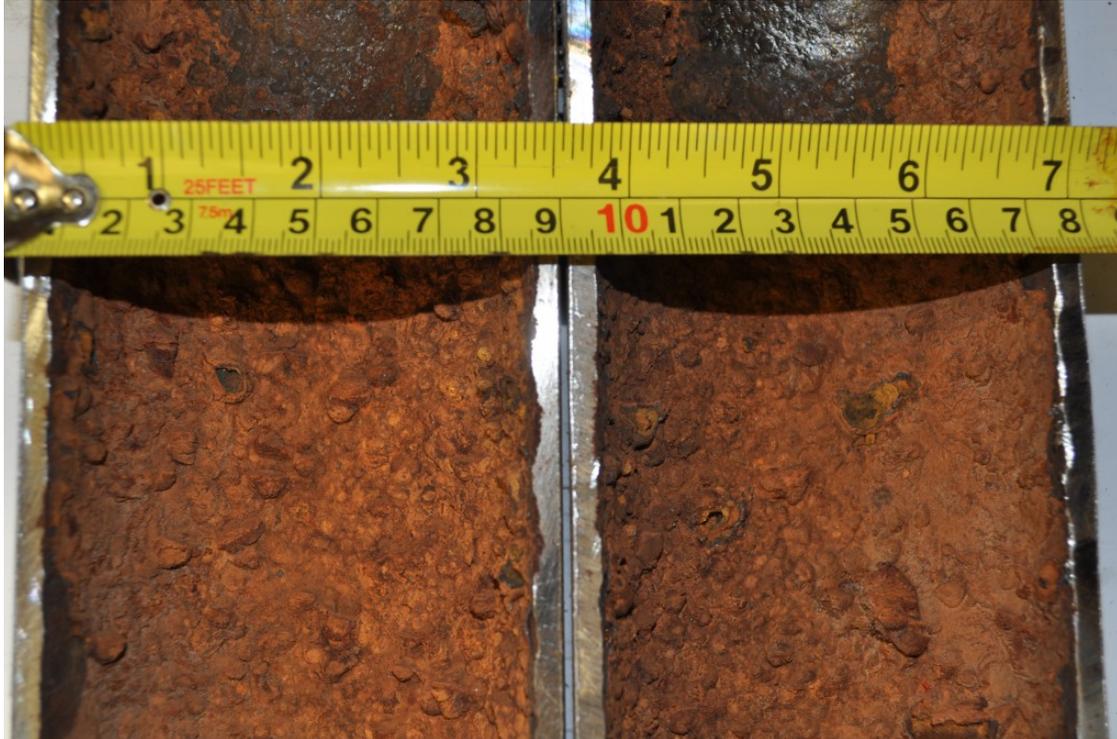
**Figure 1b:** This section was taken from the 3-inch cold water horizontal line in the mechanical room. The surface demonstrates heavy growth of rust nodules. Most of the larger ones fell off during the cutting process. Note: The side walls show evidence of deep pitting in the wall thickness profile.

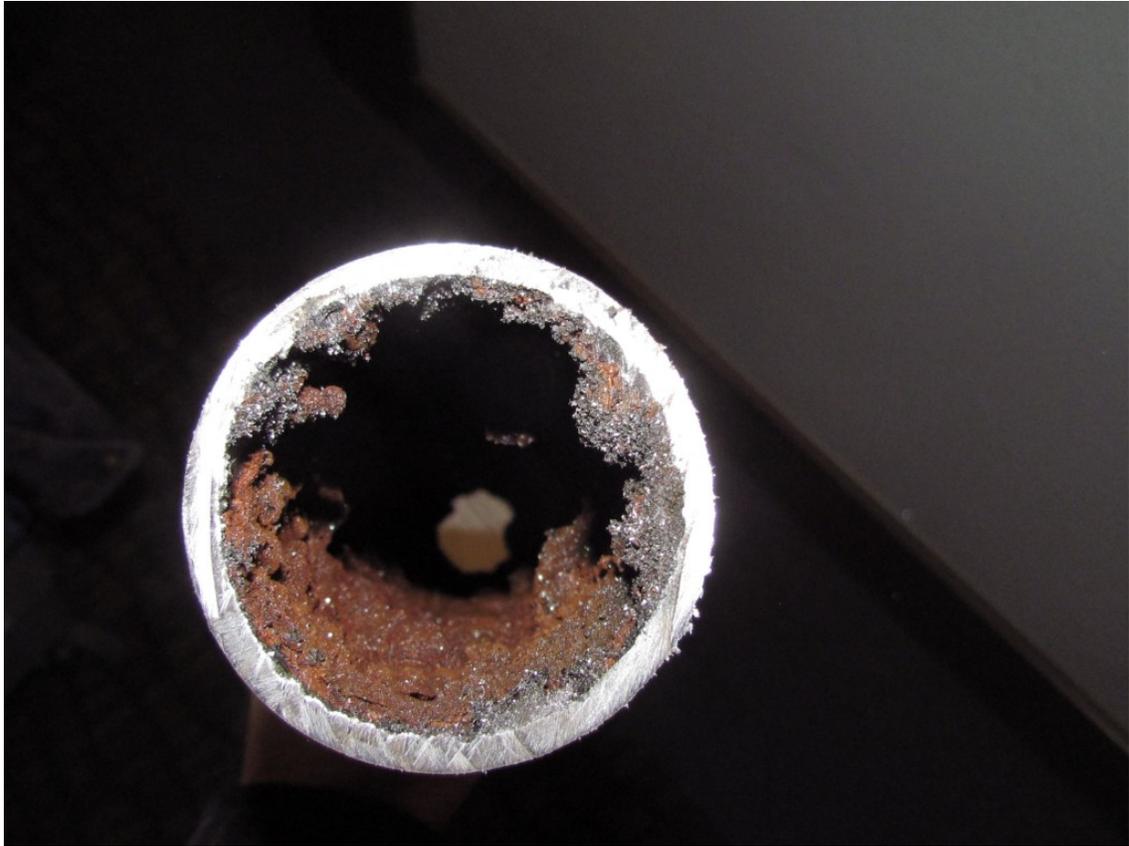
**Figure 2a:** Flow restriction reduce effective bore and promotes turbulent flow which is erosive. Large nodules can break off easily and could restrict flow in in elbows, valves or settle in low spots.

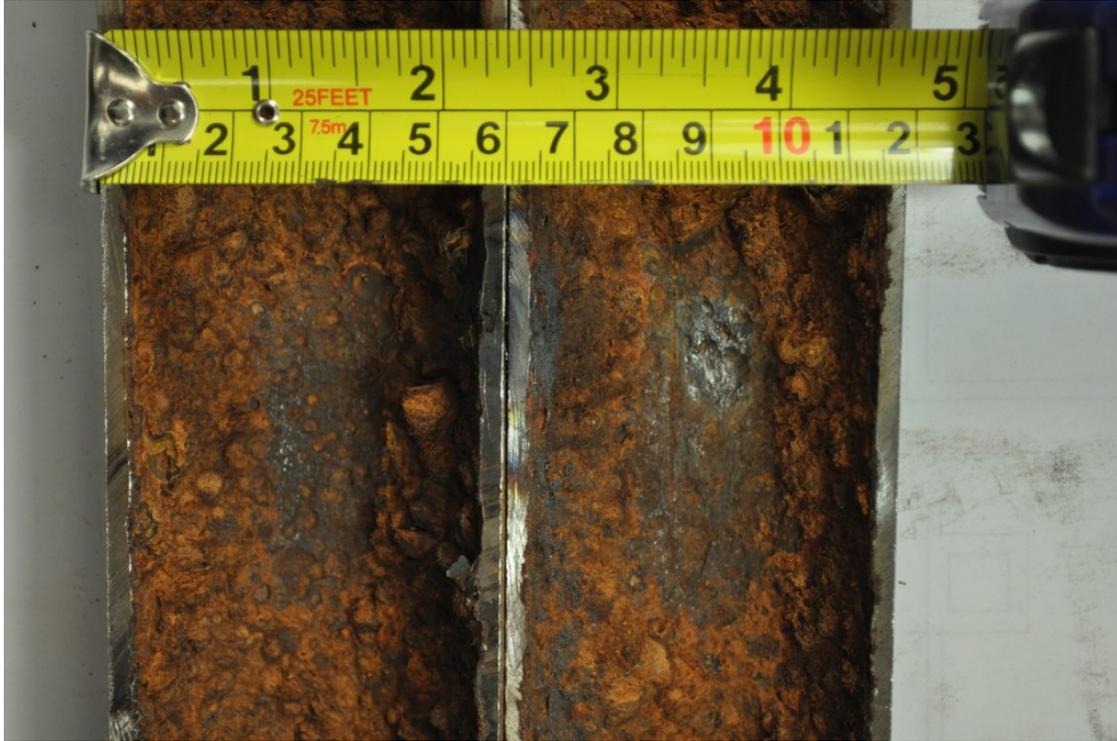
**Figure 2b:** This section was taken from the vertical cold water riser at the 16th floor. Nodules and rust debris dislodging from this height may sink to lower floors or pass into the water system. Remaining wall thickness is frequently less than 1/2 of the original dimension. Note: shiny areas have been cleaned for inspection.

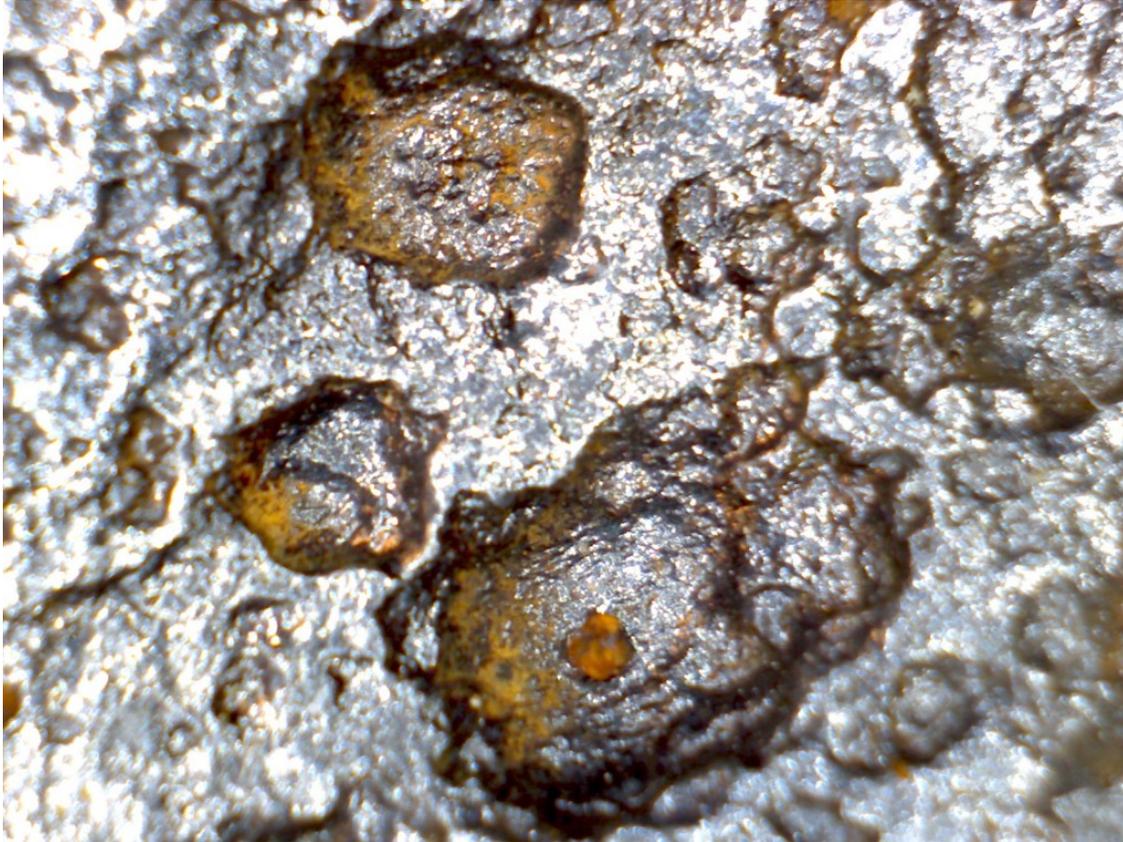
***Figure 2c:** Surface was cleaned with a pneumatic scaler and polished with a wire wheel. Resulting profile demonstrates widespread pitting. These three examples were found within a larger crater (such as seen in profile view). The diameter of the larger pit shown here is about 1/4 of an inch at widest.*

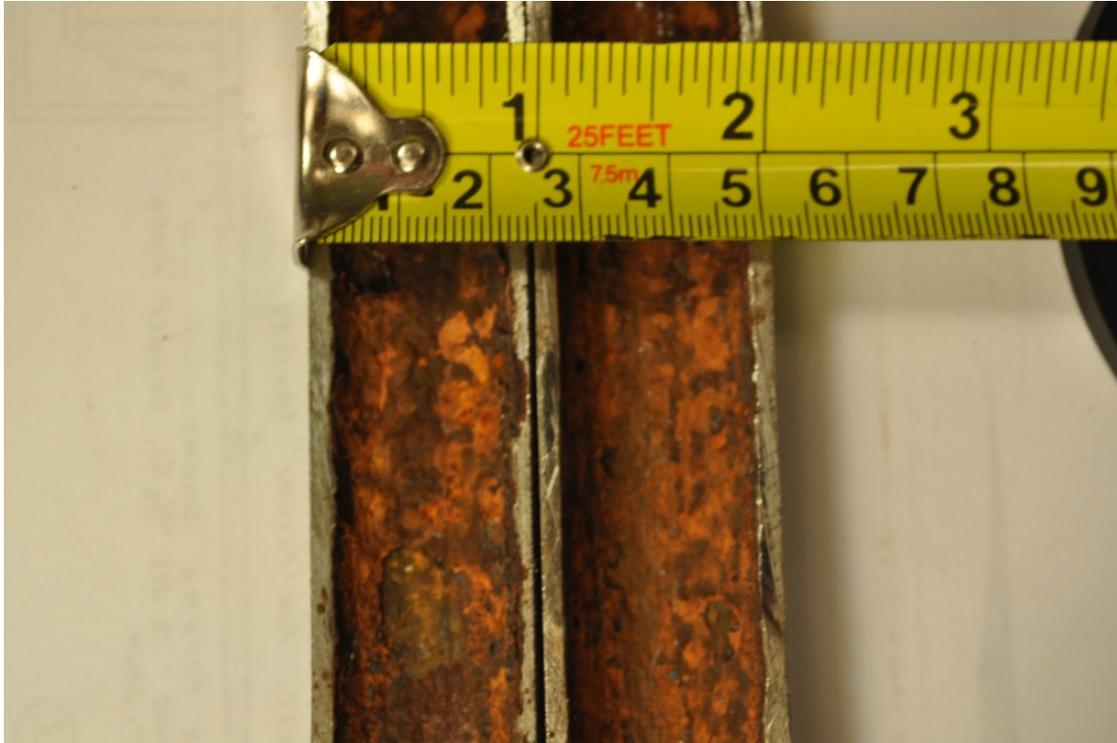
**Figure 3a:** The following Photographs was taken from the cold vertical section at unit 1D. The very thin wall section just below the scale is magnified below.

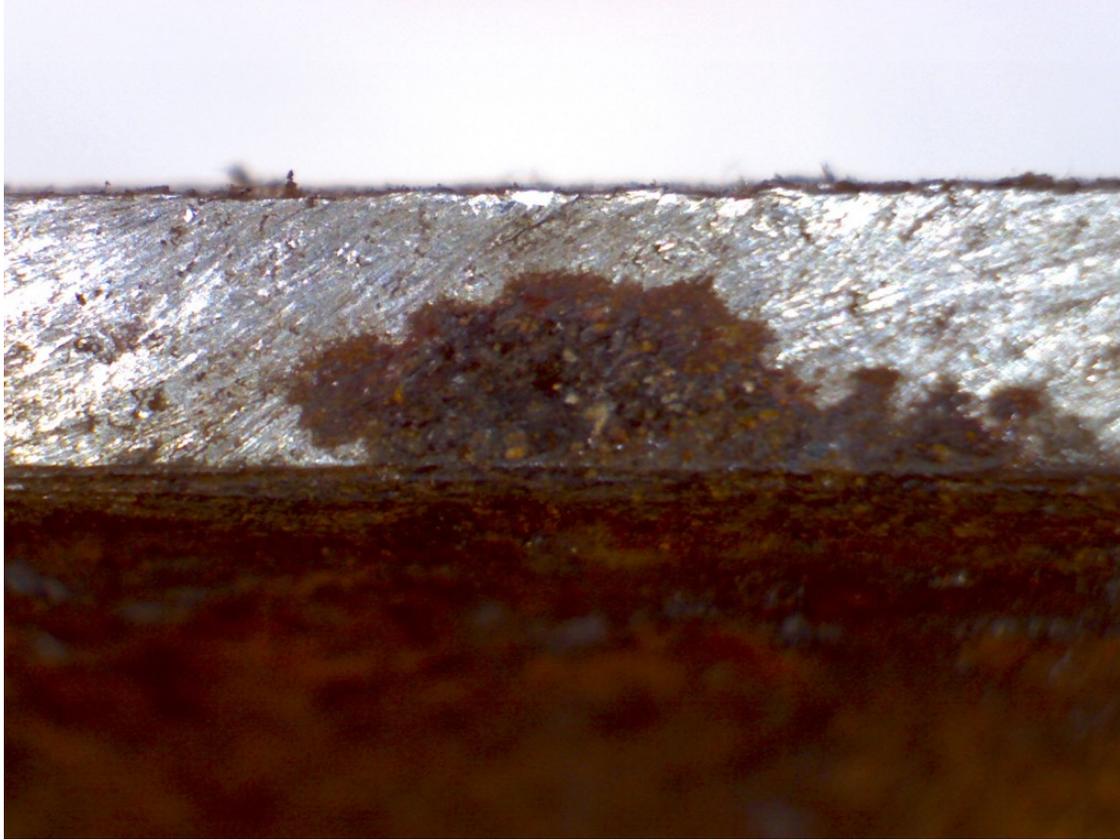
**Figure 4a;** a 1-inch diameter pipe showing less than 1/20 inches (1 mm) of remaining material. It appears that 25%-30% of original material remains.

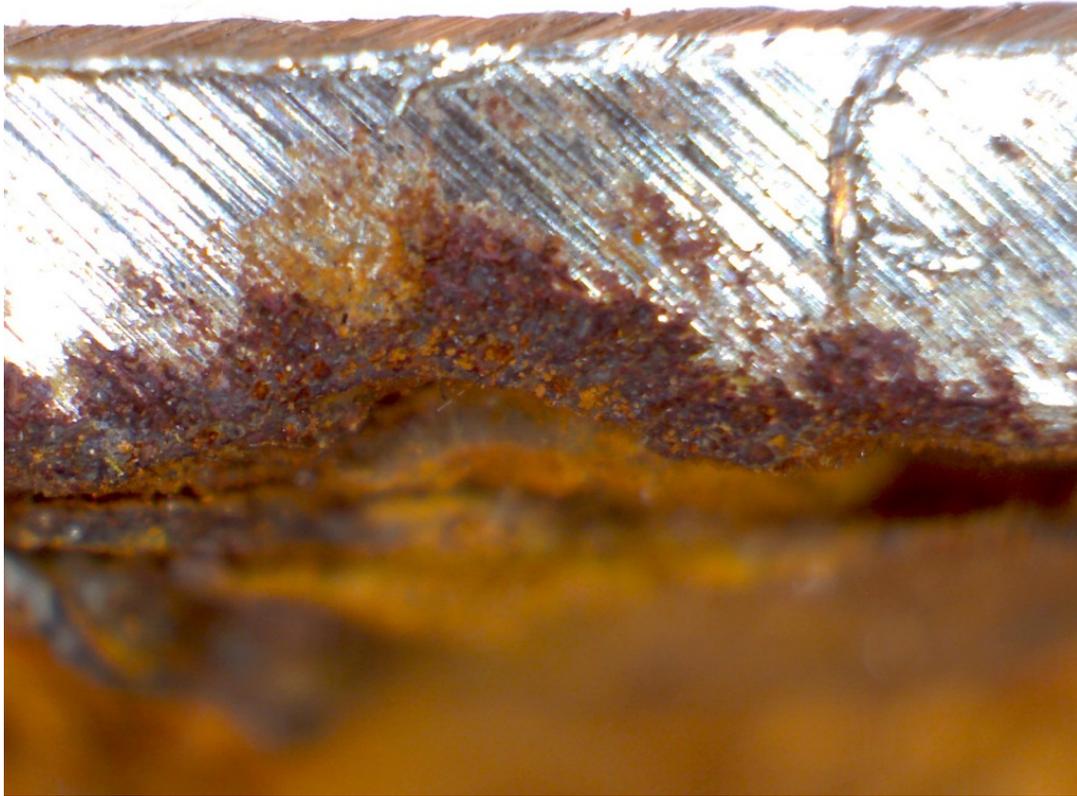
**Figure 4b:** This wall section of 2 inch pipe demonstrates less than 1mm of remaining material.

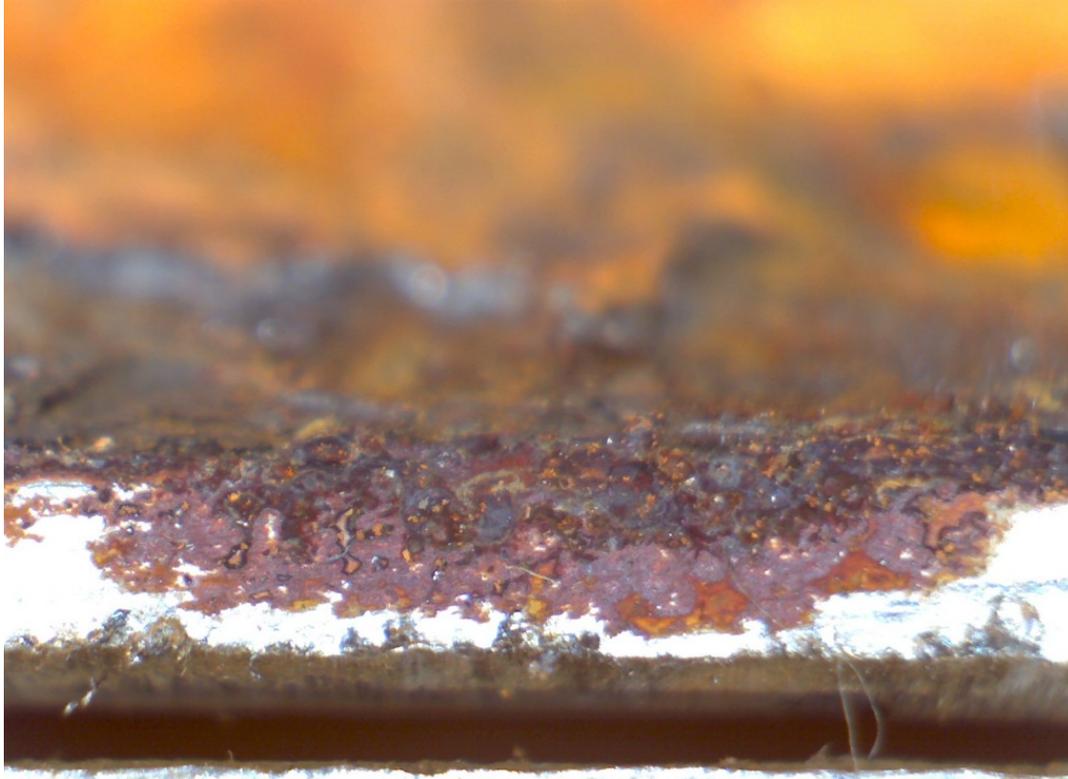
**Figure 4c:** *This 3/4 Diameter pipe with extremely thin wall section, reference figure 3a. Having found a single section this thin in a random sample suggests the possibility that some leakages currently exist or are imminent. Less than 25% of original material remains.*

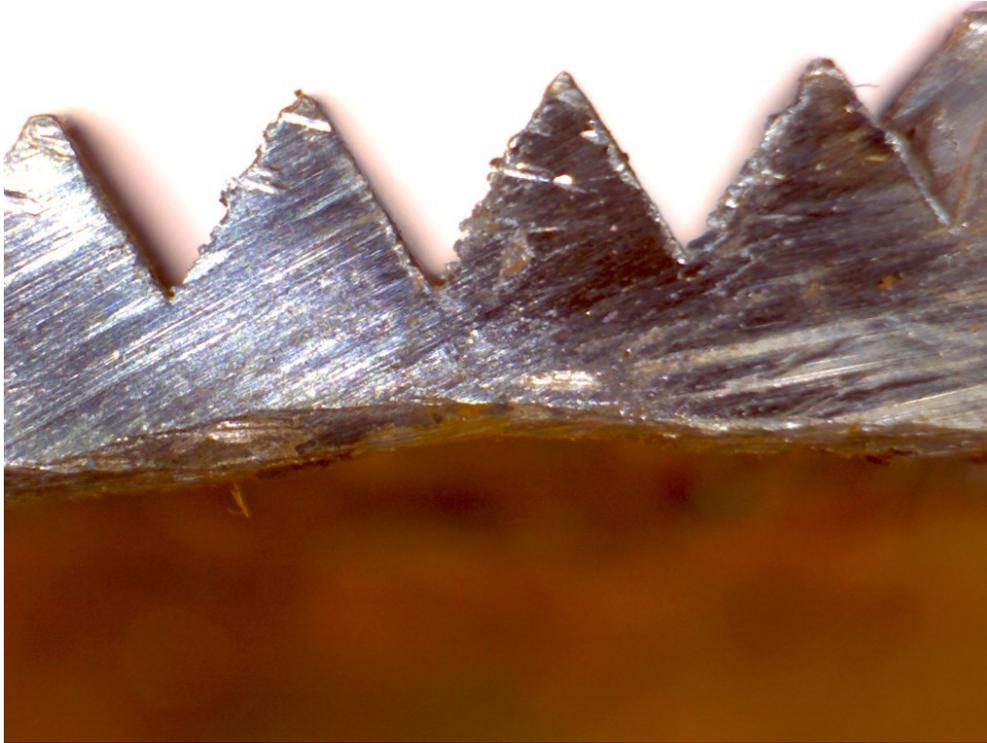
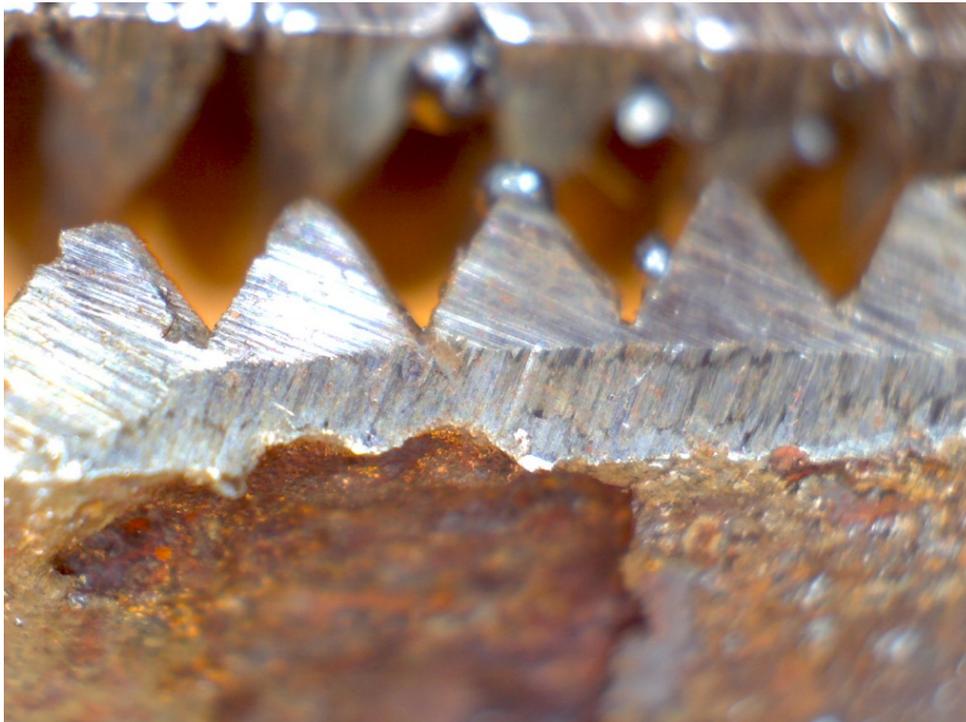
**Baseline threaded sections:** Threaded sections are particularly vulnerable to failure because they are already under a highly stressed interference fit condition, a failure would likely propagate around the circumference of the pipe or provide a path for leakage.

**Figure 6b and Figure 6c:** Threaded section demonstrating active corrosion near thread root. Less than 1 mm of material remains.

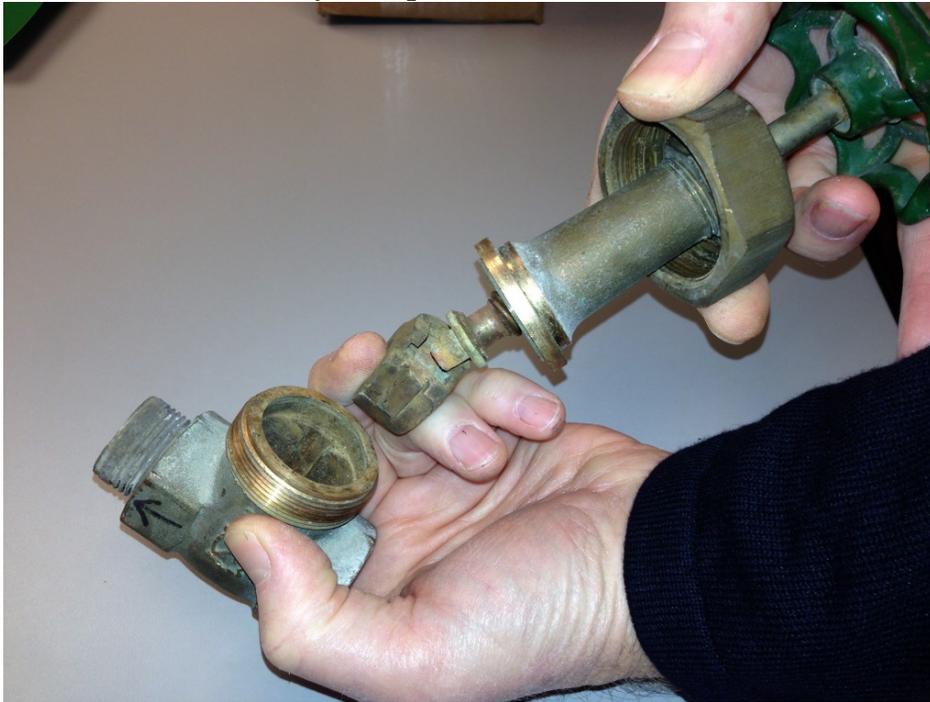
**Figure 7a:** *This valve failed at Unit 1D. The valve was used to isolate the unit even though the whole building was shut down. This was done because the mechanical contractors wanted to open the line pressure gradually upon re-energizing the water system ahead of the repair.*

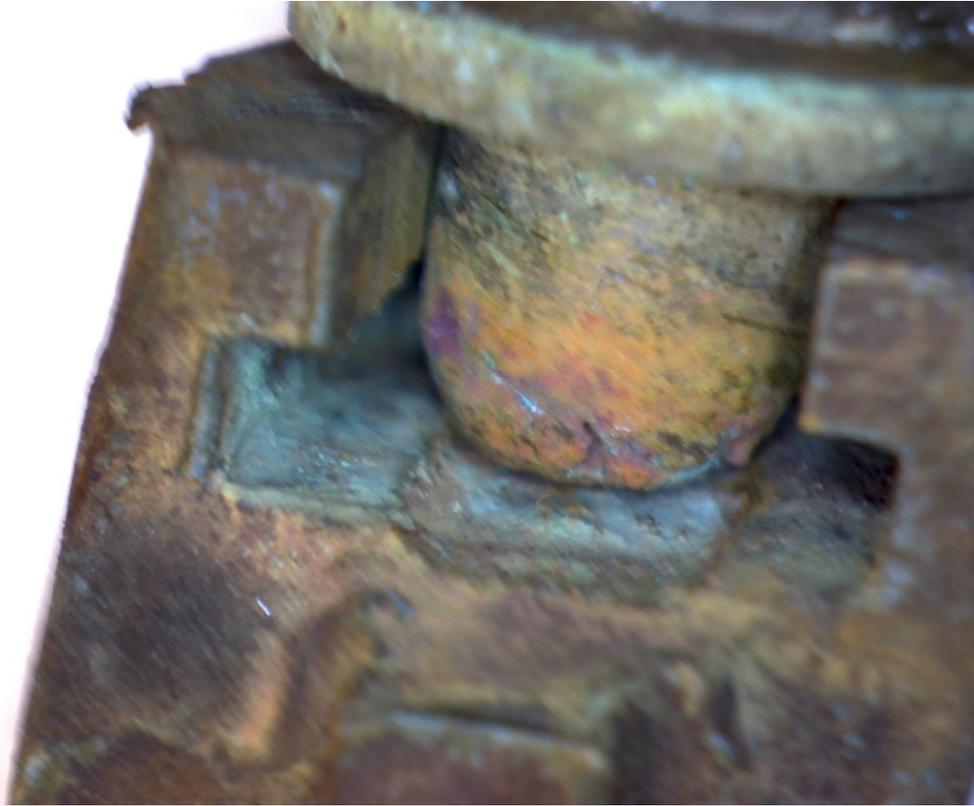
**Figure 7b:** Only a nub remains. Blue dust is typical of active corrosion in brass. Notable pitting at flange is remnant. This valve was lost long before the mechanic tried to return the system to service. This condition is more likely than not to exist elsewhere in the system.
