**Potable Water Pipe Condition Assessment For a High Rise  
Condominium in The Pacific Northwest**

December 3, 2012

Performed by: David M. Coles, PE, President, Coles Consultants and  
Daniel R. Robles, PE, MBA Community Engineering Services, PLLC

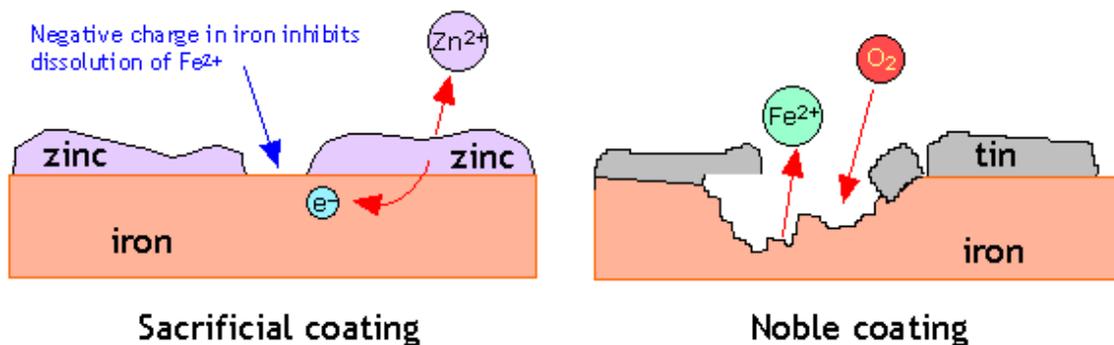
Many Residential structures currently rely on galvanized piping systems that have been in service for 40-50 years or more. Galvanized pipe is steel that has been plated with zinc. The zinc acts as a corrosion inhibitor by both coating the pipe and redirecting electrons that would otherwise accelerate the corrosion of iron. Many boaters are familiar with the application of "zincs" that corrode away from the salt water so that the rest of the boat does not.

The potable water system in this structure is more than 40 years old and has largely lost the zinc protection and rusting is active in the underlying iron pipes. The rate at which the rusting process advances depends on many factors from the quality of the water (hardness, PH Balance, Chlorine, etc) to the presence of oxygen, turbulence, and rapid changes in direction of flow. The process of corrosion also may introduce contaminants into the water, which would be tested with a separate laboratory water quality assessment.
